# MINOS+ Status Report

Xinjie Qiu  
All Experimenters' Meetings  
November 11, 2013

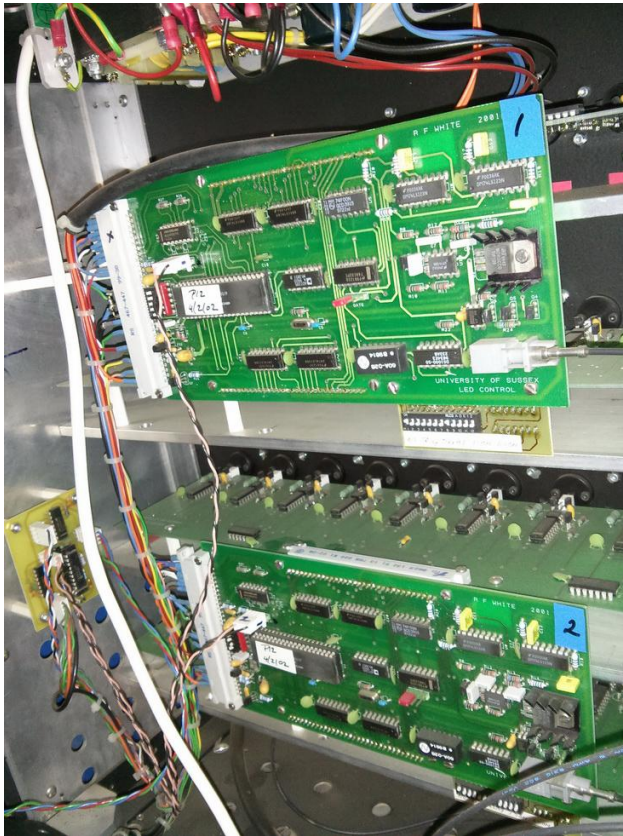
- Light Injection (LI) Gain code failing
  - Can't match hits to a LI pulse
  - One new bad LED (PB=0 LED=1) showed up ~ Oct 22, exceeding the maximum allowed number (3) of bad LEDs
  - Temperately increased the bad LED number tolerance from 3 to 4 in the code
  - Opened the front panel of PB(pulser box) to examine how the LI is setup
  - Inspected the LI controller board, no obvious problem found
  - Not immediately clear how and if we can replace a LED or move the fibers from the bad one to a working one
  - Will consult with Phil Adamson, our local LI expert
  - Update this morning: the bad LED number went back from 4 to 3 again.
  - Further investigation is going on

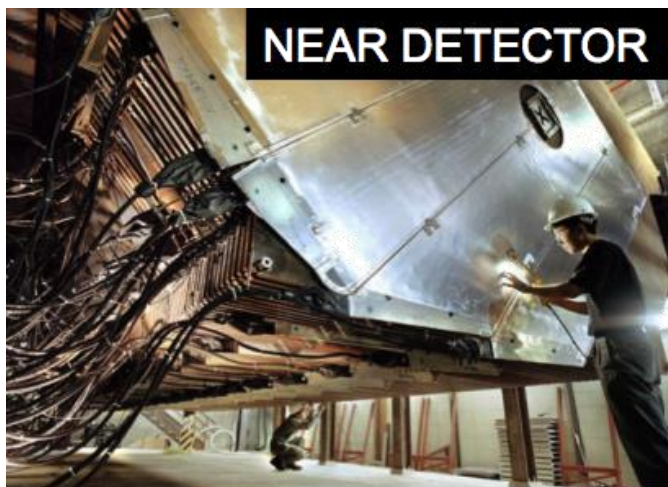
- Mislabeled cable caused missing plane in LI Hit/Gain map
  - A previous attempt was made to fix a hot channel
  - Found some mismatched labels on both end of the master to minder cables
  - Re-cabled them as we believed it was the correct order, but evidently broke the LI readout (LI dynodes connected to the wrong Minders)
  - Put the cables back as they were, plane 101 LI is working again
  - Re-label the connector of the cable on the master end to make them consistent with the minder end, without moving or relabeling any minders.
- Hot channel in 0-17-2
  - High ~210kHz
  - A minder swap was performed, the master crate was power cycled, failed to fix the issue
  - Will continue the investigation.

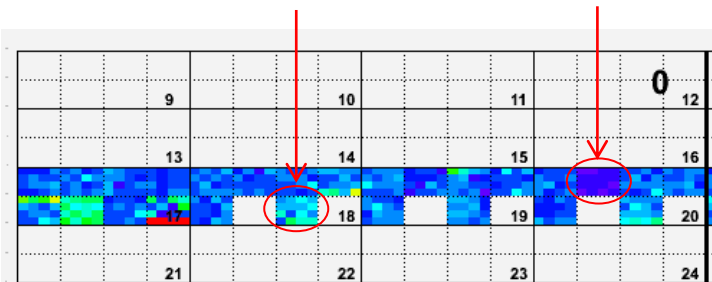
- The problem
  - Low rate on channel 0-18-6 (Type 4 Alner box) and 0-20-1 (Type 5 Alner box)
- Fix of channel 0-18-6
  - Swapped with a spare Type 4 Alner box in 0-18-6
  - Low rate channels became normal.
  - Swapped with a spare Type 5 Alner box in 0-20-1
  - Low rate channels were still there.
- Troubleshooting on 0-20-1
  - Checked on HV card, HV cable, cable from box to minder, etc.
  - Everything seems OK
  - Though maybe a bad spare box, swapped with another spare Type 5 Alner box in 0-20-1
  - Low rate channels were still there.
  - Really confused ... another bad spare box?
  - Checked on HV card, HV cable, cable from box to minder, etc. , again
  - Everything seems OK
  - Moved a known good Alner box from 0-20-5 to 0-20-1
  - Previously low rate channel 0-20-1 is OK now
  - Conclusion: The problem was due to "bad" Alner box

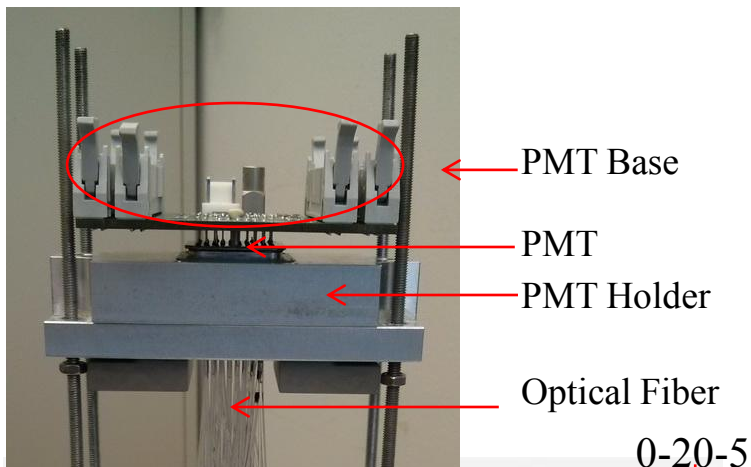
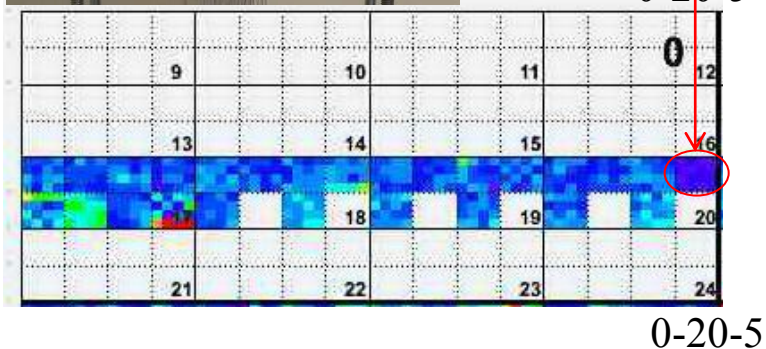
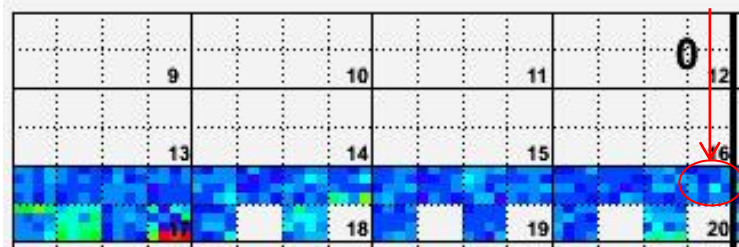
- Alner box repair
  - Retrieved a PMT from one CalDet Alner box to replace the one in the “bad” box
  - Put it back into the detector, problem remained
  - Really confused... Another bad PMT?

- Cause of the problem figured out
  - CalDet box has 1:1 channel readout, Type 5 box has 4:1
  - Thought the multiplexing is done by the cable
  - Measured the cable, it's not the case

- Consulted with Oxford, multiplexing is done by the PMT **base**
    - CalDet box has regular PMT bases
    - Type 5 box has multiplexed PMT bases
    - 4 anodes are electrically shortened together on the base, a single signal is routed to the connector

- Non-multiplexed base was used, both the box previously used in the detector and the in two spares
  - Only 1 anode is read out, causing low rate at 1/4 level

- Final fix
  - Opened up the box and indeed the PMT base was not multiplexed
  - Replaced the regular base with a multiplexed one, also made sure PMT stays with its carefully aligned same aluminum holder

- Installed the box in the detector
  - Online Monitor plots show the channel is normal now!
  - Only have one spare MXP base, Oxford will send us some PMT assemblies spares

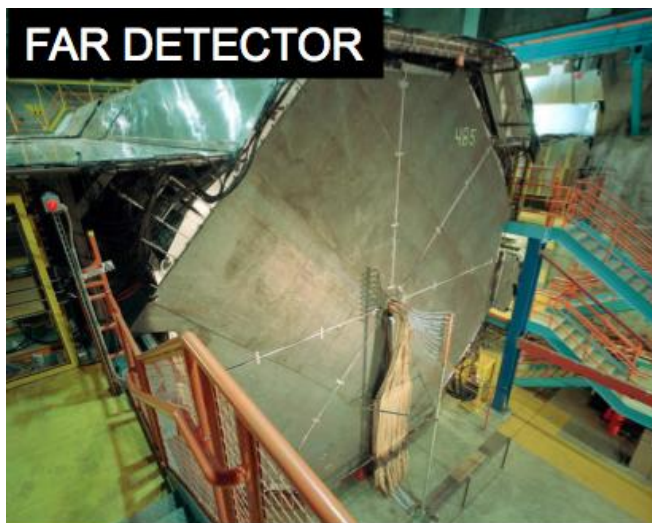
- Regular detector maintenance
  - ROP (*Read-Out Processor*) #6 crashes DAQ
    - Changed ROP cards, re-initialize the board
    - ROP06 Card kept failing
    - Eventually replaced it with a new one from ND (ND ROP4)
  - HV Card replacement on mainframe 7
  - DAQ rc
    - FD RC CPU temperature over threshold warnings
    - Fan change on DAQ rc
- FD DAQ running happily and smoothly
